BOSPHORUS Audit

NAVIGATION ASSESSMENT (REMOTE) VDR ANALYSIS REPORT

SHIPS' NAME	TBN
COMPANY	Tbn
ANALYSIS BY	Bosphorus Audit
AUDITOR	Capt. TBN
REPORT DATE	14 th Dec 2020
NAVIGATION DATE	25 th Nov 2020
LOCATION	Bosphorus Strait Passage
REPORT NUMBER	BG081401

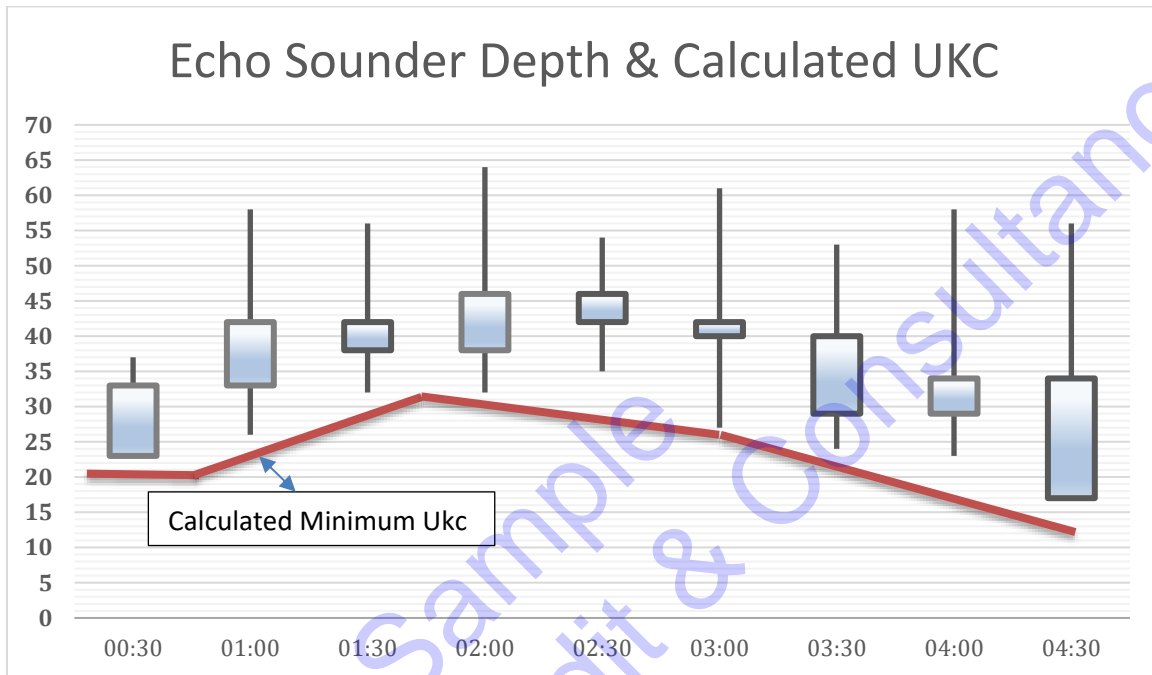
Echosounder alarm were audibly tested before anchorage. Echo sounder alarm set points has been sought properly.

No gaps has been observed. Company required UKC has been implemented properly.
